WAAS Technical Report
William J. Hughes Technical Center
Pomona, New Jersey
May 23, 2005

DR#1: C&V Source Switch Caused WAAS Service Outage
GPS Week/Day: Week 1321 Day 4 (5/5/2005)

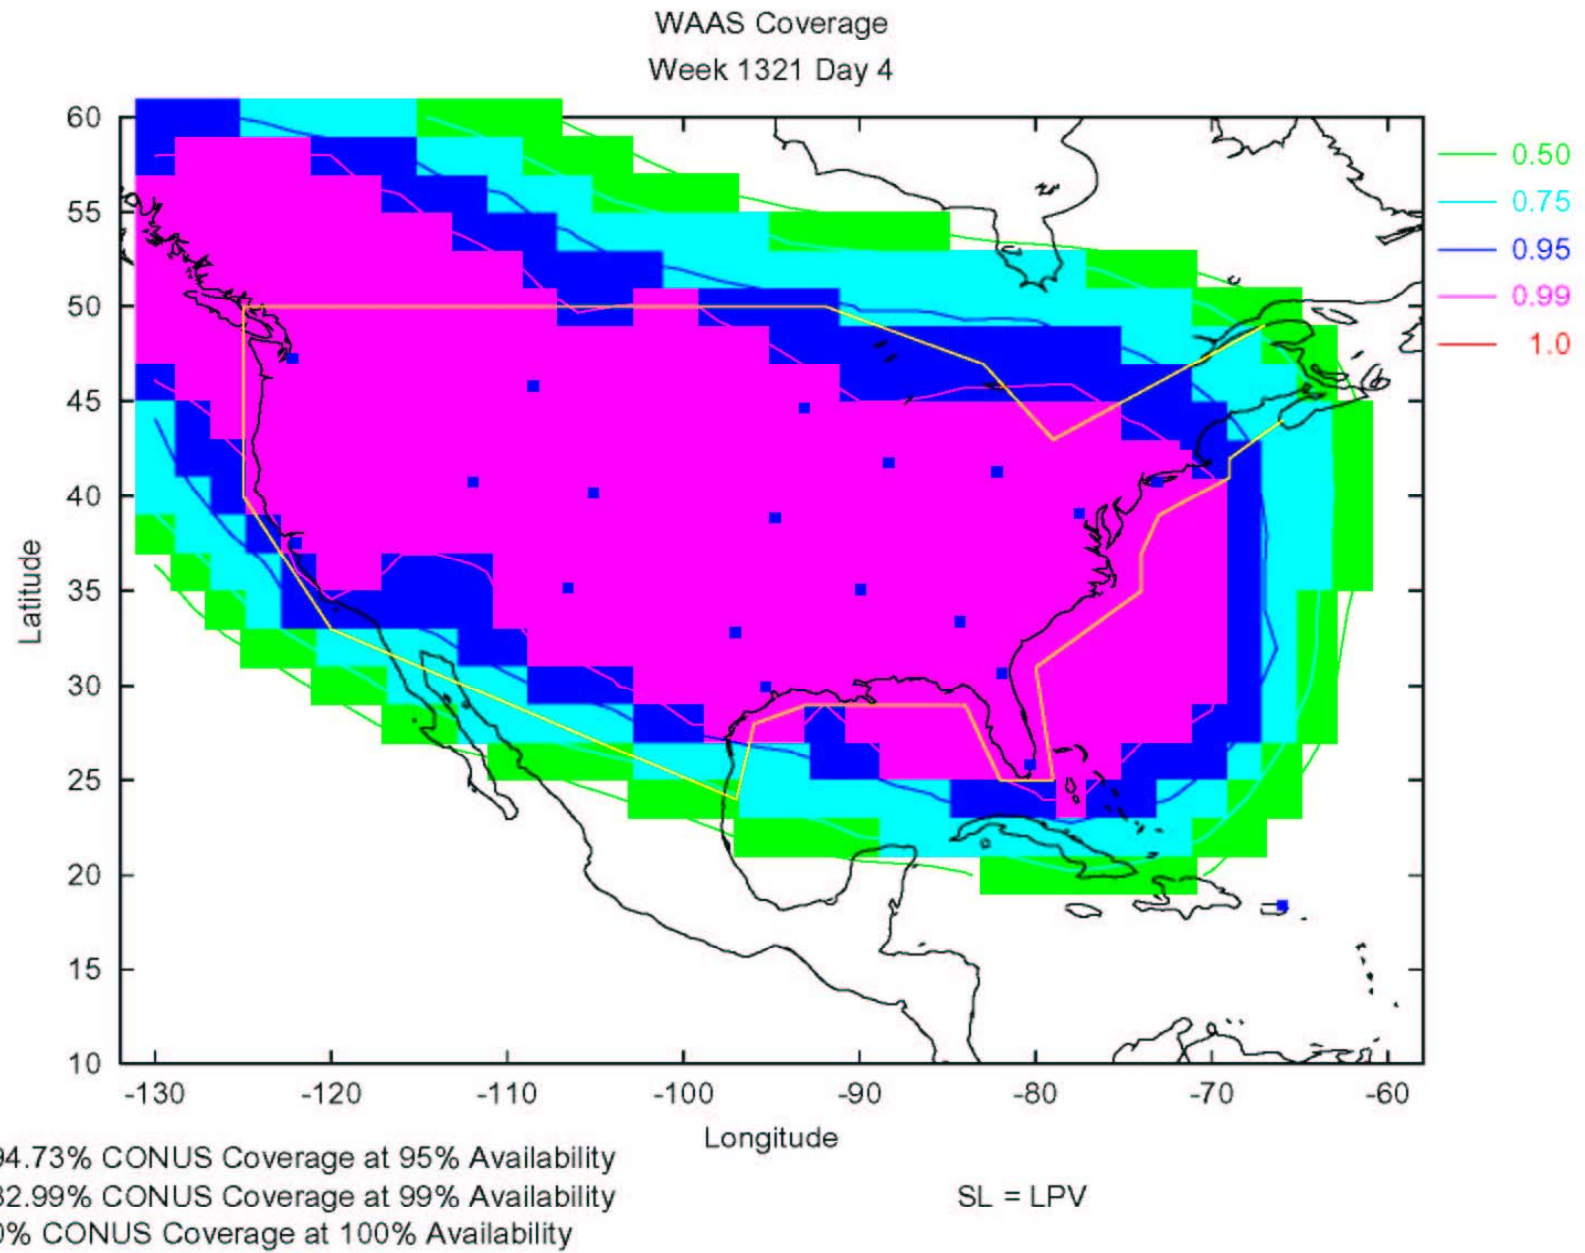
Fig. 1.1 – LPV Coverage, 5/5/2005

This interruption of service can be observed very clearly by inspecting the following plots. Figures 1.1 and 1.2 are taken from daily coverage processing. The first (Fig 1.1) shows the complete loss of 100% LPV service over CONUS for this day while Figure 1.2 shows the complete loss of both 99.9% and 100% NPA service over the NPA service volume.

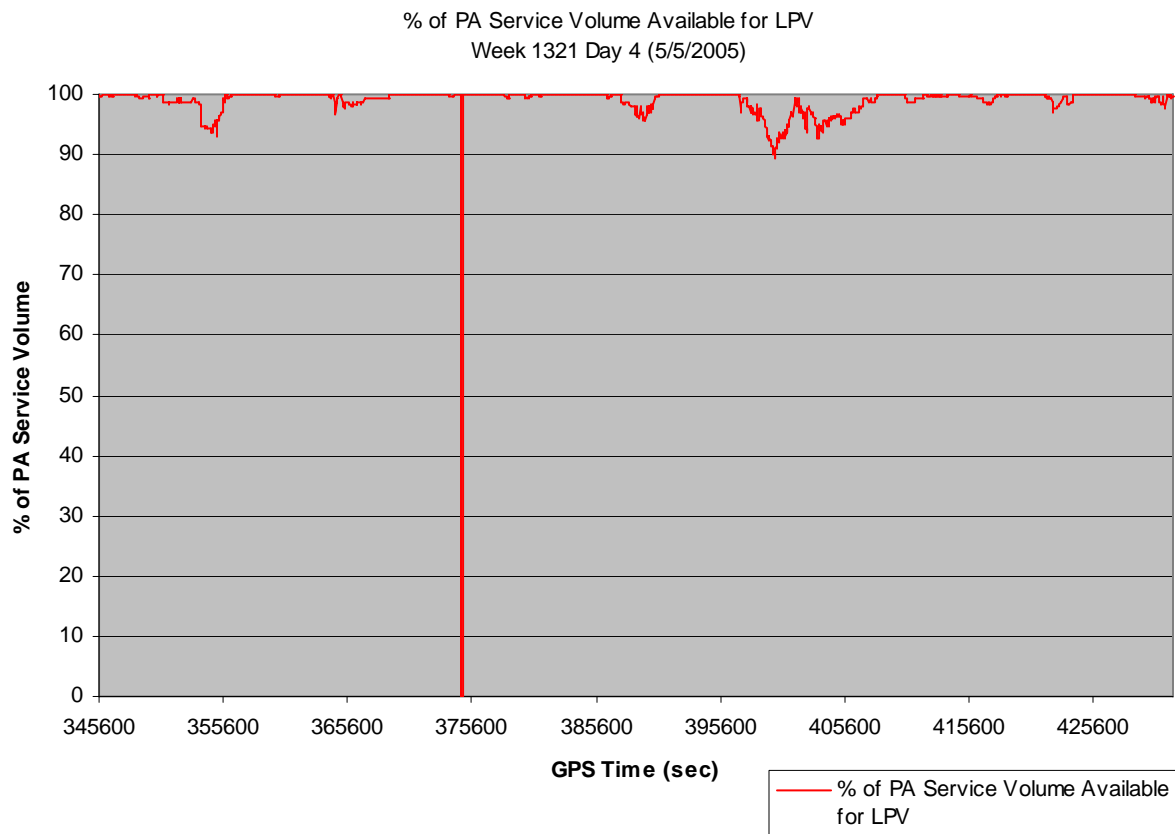
Fig. 1.3 – % of CONUS Service Volume Available for LPV, 30 second sampling

The effect of this event on the availability of service over the CONUS and NPA service volumes can be more directly correlated to this event by observing Figures 1.5 and 1.6. These plots show the instantaneous coverage over the course of the day with 30 second sampling. At the time the Type 0 alert was issued, GPS time of week 374748, both LPV and NPA service levels are entirely unavailable over both the CONUS and NPA service volumes respectively.

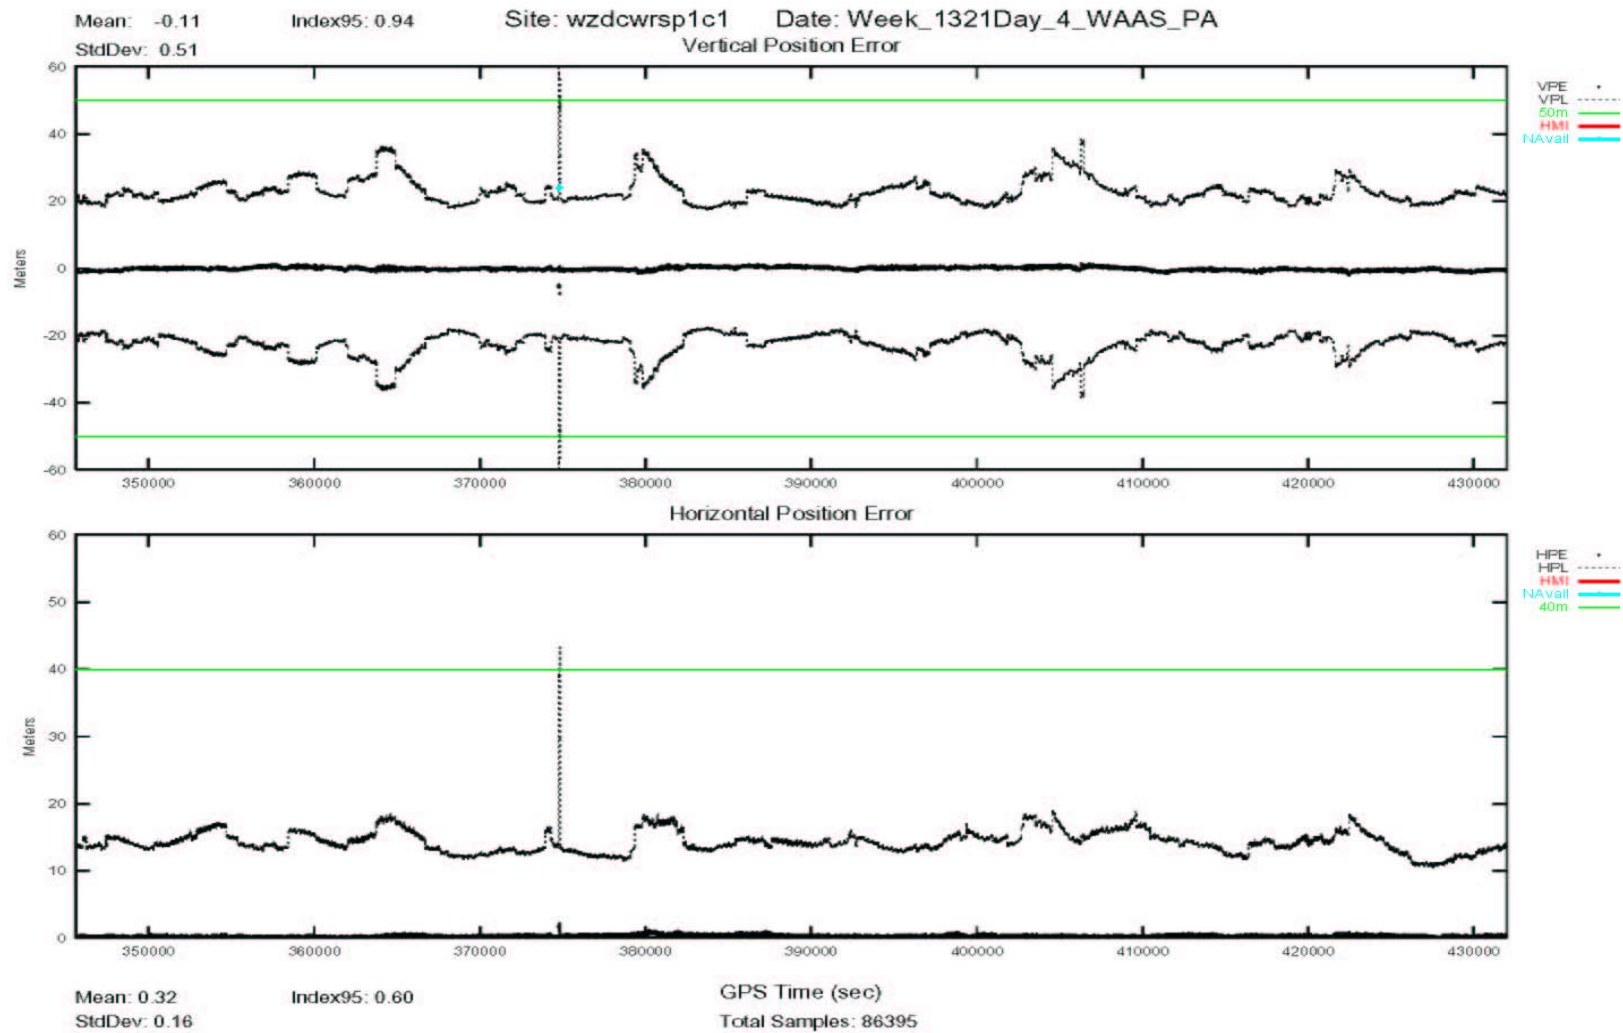
Figure 1.5 - Vertical and Horizontal Error/Protection Level plots from Washington DC WRS

The loss of service availability also becomes more evident from a user perspective. The following plots represent data taken from WAAS reference stations. Figure 1.5 was created from data collected at the Washington DC reference station. Figure 1.6 is from Kansas City and Figure 1.7 is taken from Los Angeles. The effects of the Type 0 alert resulting from the C&V failure are clearly evident on the plots at the time the alert was issued, GPS time of week 374748. An obvious spike in position errors and protection levels can be seen across all plots.
