**WAAS Technical Report**  
**William J. Hughes Technical Center**  
**Atlantic City International Airport, New Jersey**  
**5/30/13**

**DR #114: LPV Service Outage Due to Consecutive SV Alerts on PRN 138**  
**GPS Week/Day: Week 1740 Day 3 (May 15, 2013)**

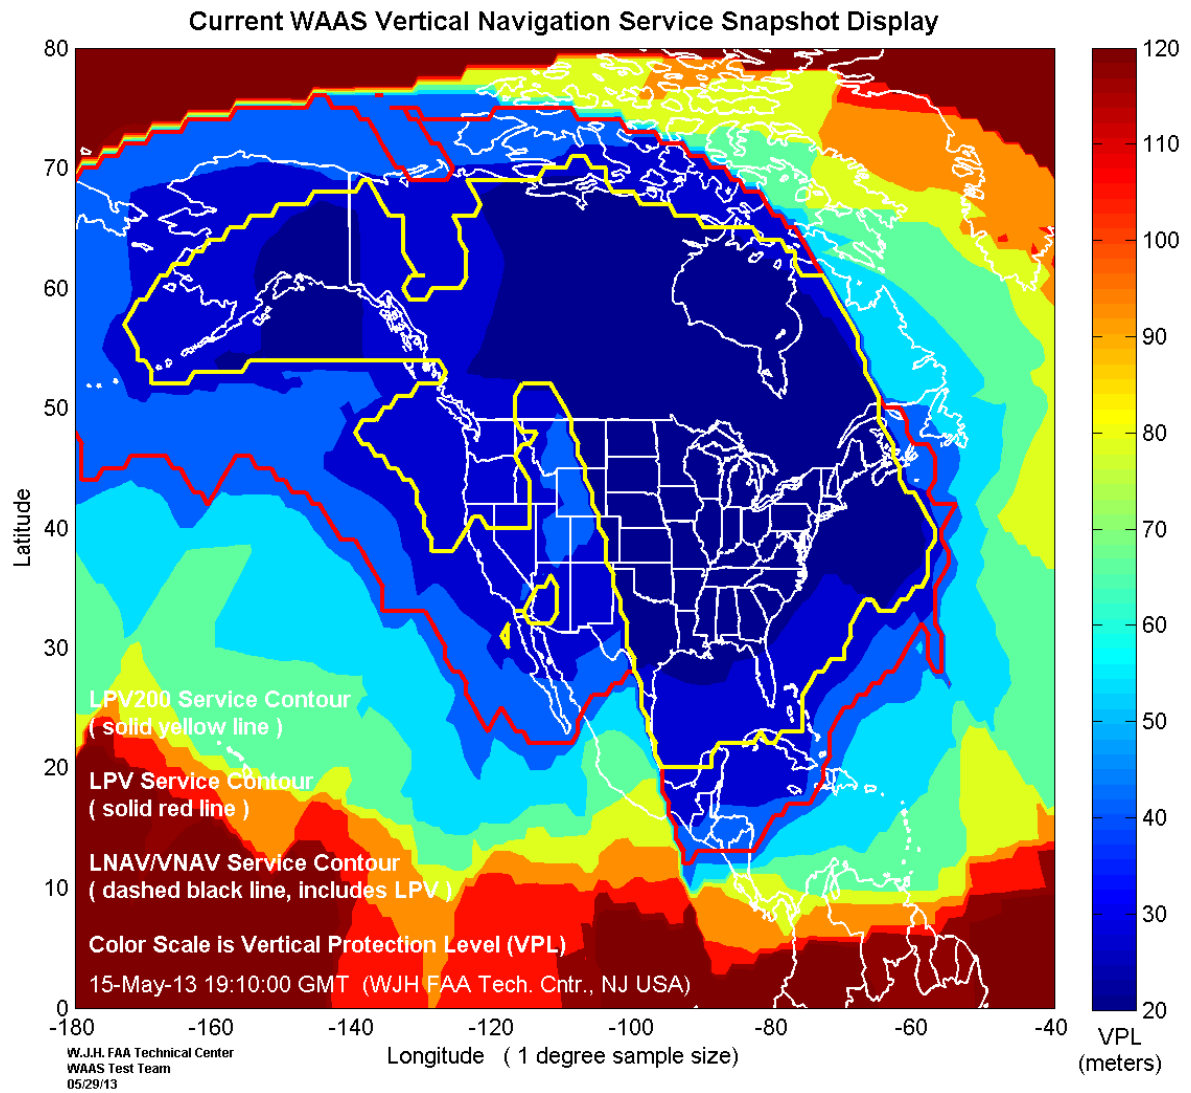
**Figure 1: WAAS Coverage Contours at 19:10:00 GMT on May 15, 2013**

Since there were more than 12 seconds elapsed since the previous Type 2 fast correction, PRNs 1-13 timed out.

Figure 1 shows the WAAS Coverage Contours at 19:10:00 GMT on May 15, 2013. WAAS service was significantly affected by the timeout of the Type 2 fast correction.

A timeout of the Type 2 fast correction led to the timeout of PRNs 1-13. This caused a short (two second) LPV service outage at the WAAS reference stations listed in Table 1. The service outage was from 19:09:59 GMT to 19:10:01 GMT.

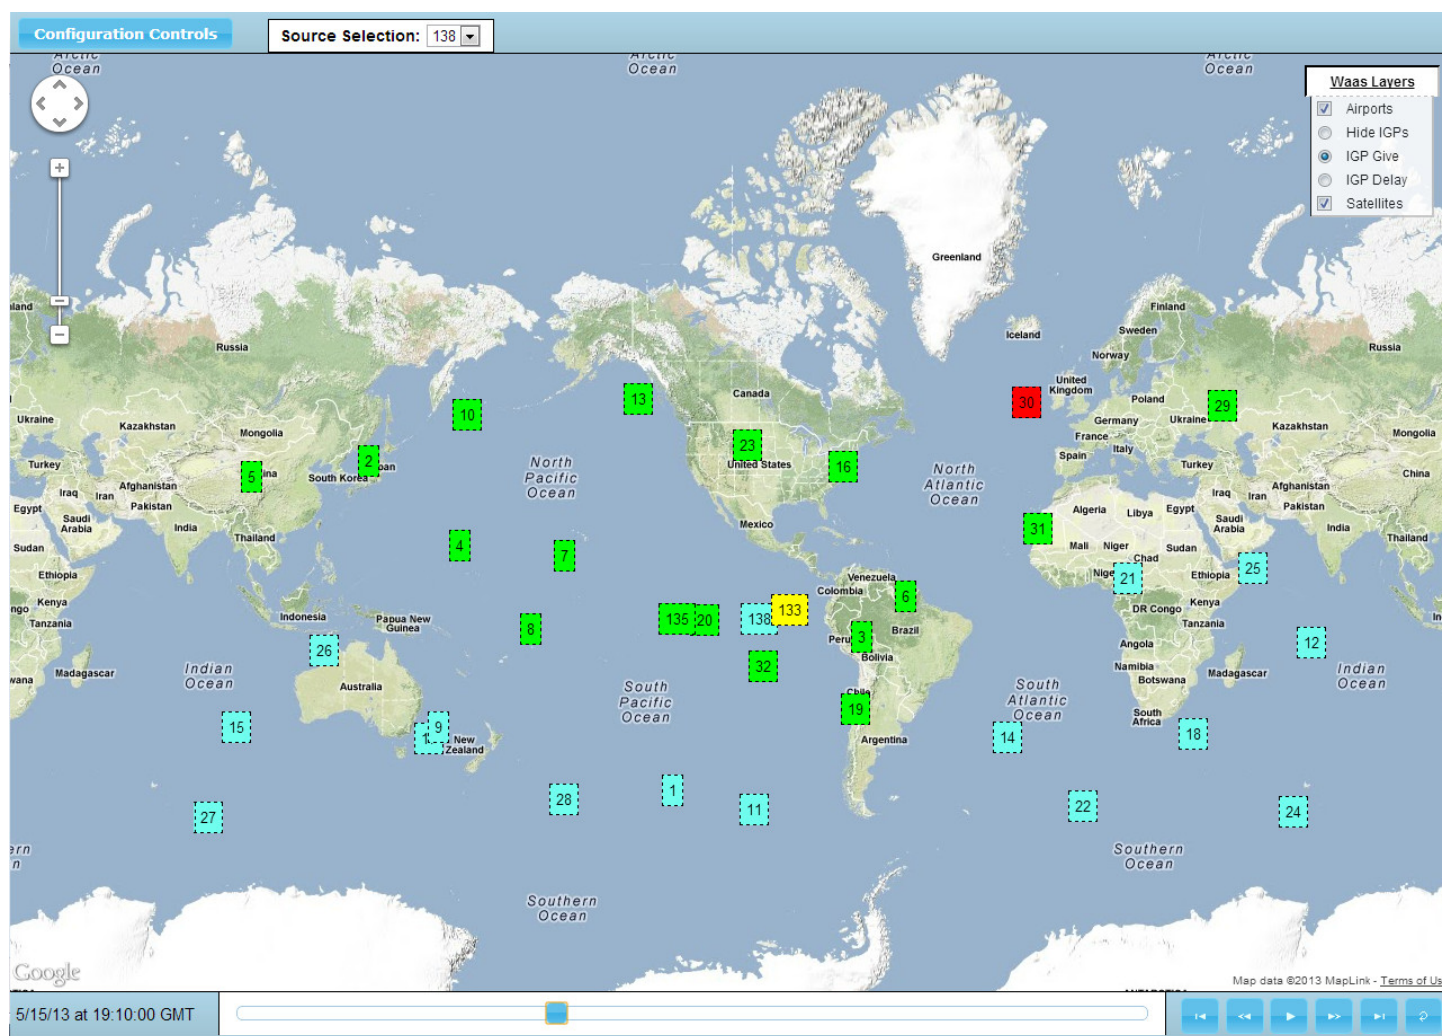
**Figure 2: Location of WAAS satellites near the time of the message Type 2 timeout**

Figure 2 shows the location of the satellites that were affected by the timeout (with PRN 138 as the source of WAAS corrections). There were 17 GPS satellites in PA mode. Nine satellites were PRN 1-13. WAAS monitored satellites appear in green boxes, while satellites in blue are WAAS “Not Monitored.” PRN 30 was set “Do Not Use” by WAAS, and the ranging quality on PRN 133 was “NPA.” PRN 138 was set to “Not Monitored” also.
