**WAAS Technical Memorandum**  
**William J. Hughes Technical Center**  
**Pomona, New Jersey**  
**March 23, 2010**  
*Author(s): Bill Wanner*

**DR #90 Extended SIS Outage on CRW (PRN 135)**  
**GPS Week/Day: Week 1569 Day 6 (2/6/2010)**

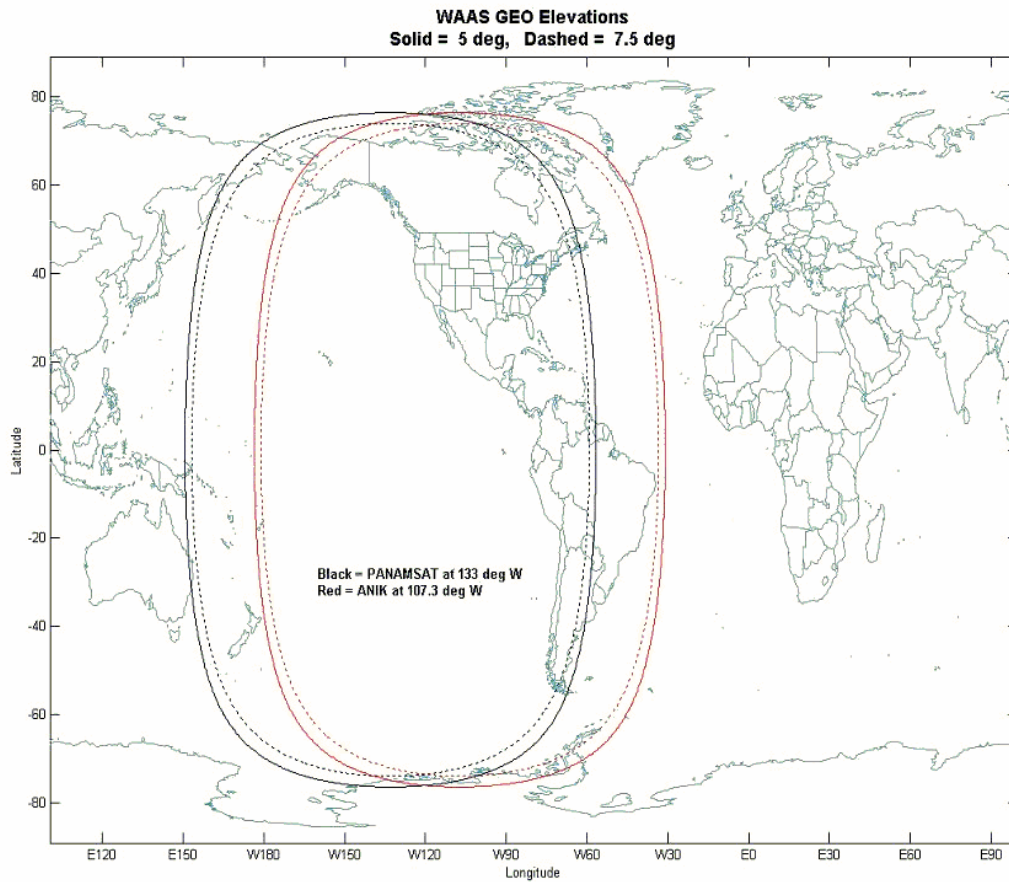
**Figure 1. CRW and CRE GEO Footprints**

The loss of the CRW SIS causes a loss of service in the area where the CRE GEO and the CRW GEO do not overlap. The location where there is no overlap includes northwestern Alaska and the western part of the Pacific Ocean, beyond the WAAS service volume. Figure 1 shows the footprints for the CRW and CRE GEOs.

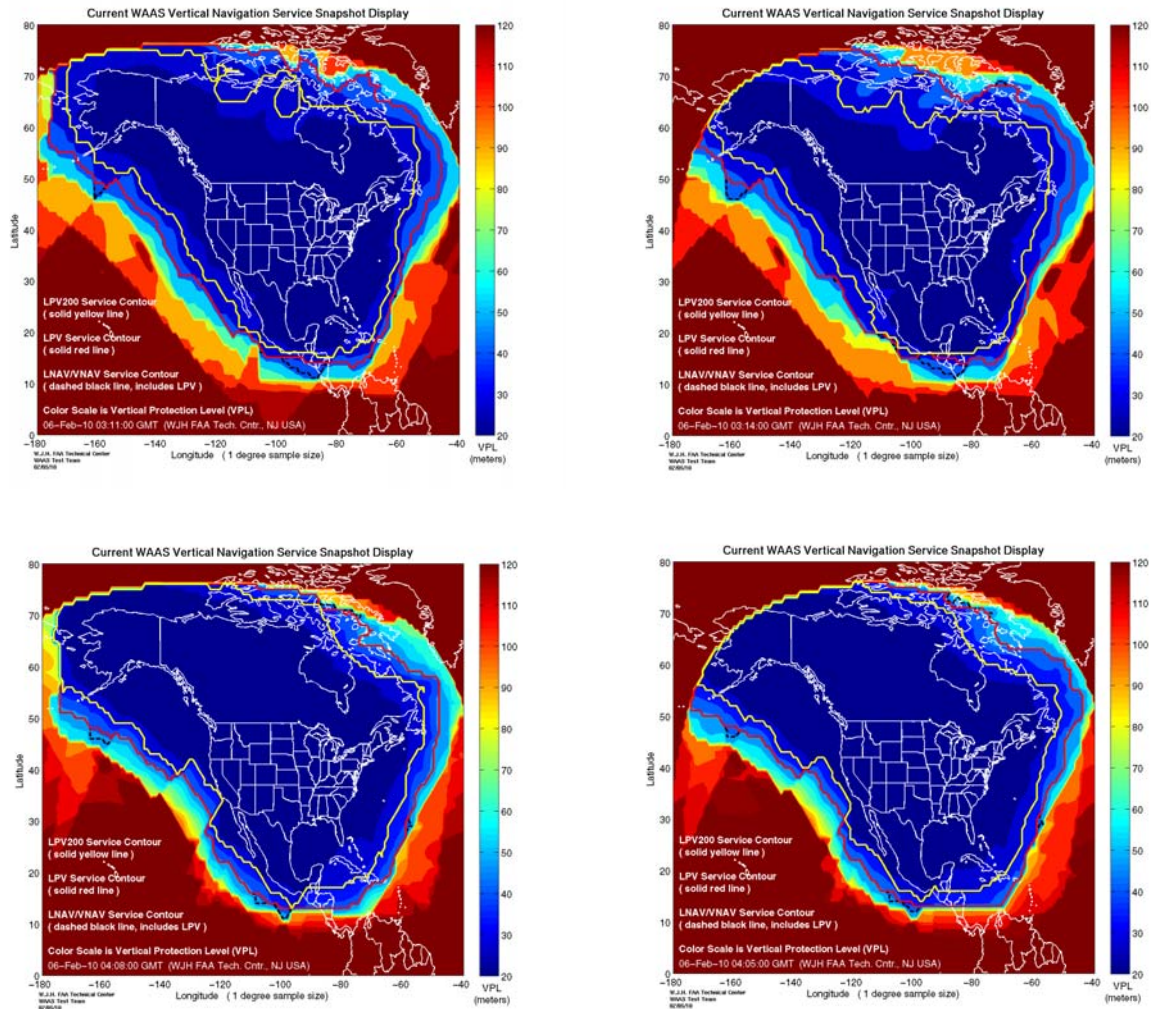
**Figure 2. North America Coverage Plots during First CRW SIS Loss**

The CRW GEO stopped transmitting at 3:11 GMT. At this time the C&V commanded Napa to be the backup GUS and both GUSs had a state of backup GUS. At 4:03 GMT the WAAS Operations Specialist (WOS) restored the SIS for CRW. Figure 2 shows a basket of coverage plots for North America before, during, and after the first CRW SIS event. Following clockwise and starting with the upper left plot the times for each of the plots are 3:11, 3:14, 4:05, and 4:08 GMT.

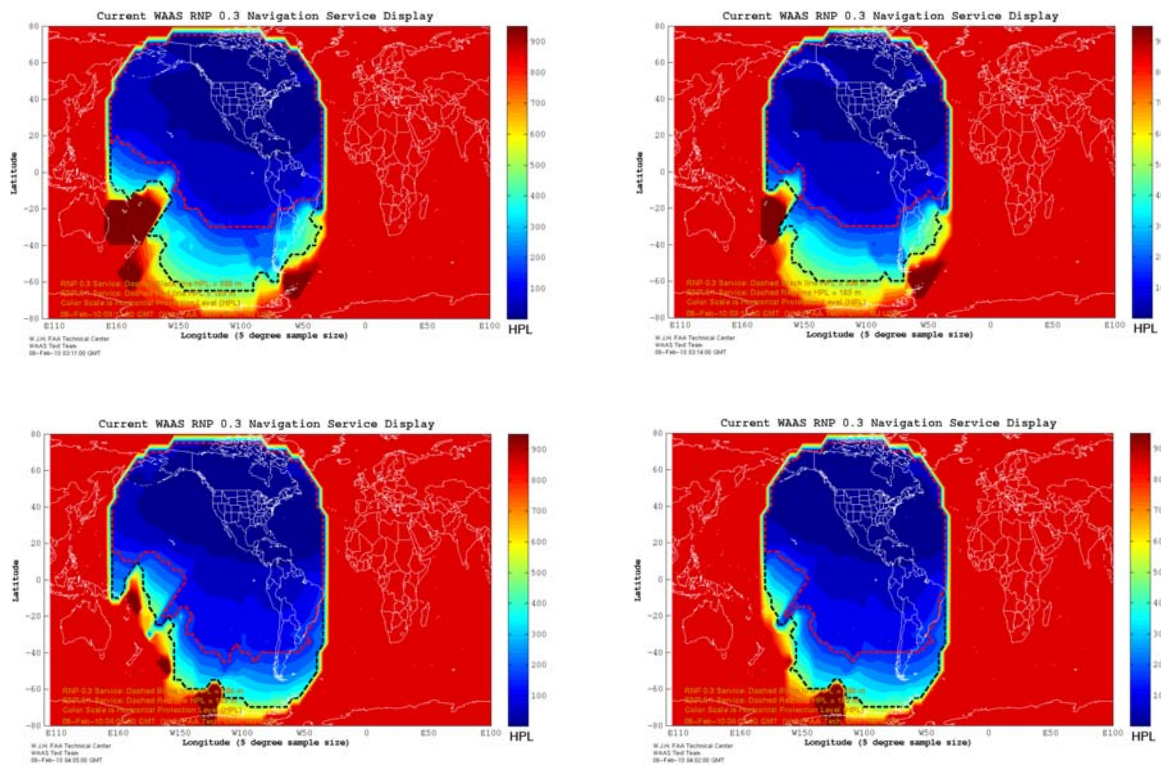
**Figure 3. WAAS Service Volume during First CRW SIS Loss**

Figure 3 shows plots of the entire WAAS service volume and the effect of losing the CRW SIS. The SIS loss follows closely with the GEO footprints shown in Figure 1. Similar to Figure 2, four plots are shown in Figure 3. Following clockwise and starting with the upper left plot the times for each of the plots are 3:11, 3:14, 4:02, and 4:05 GMT.

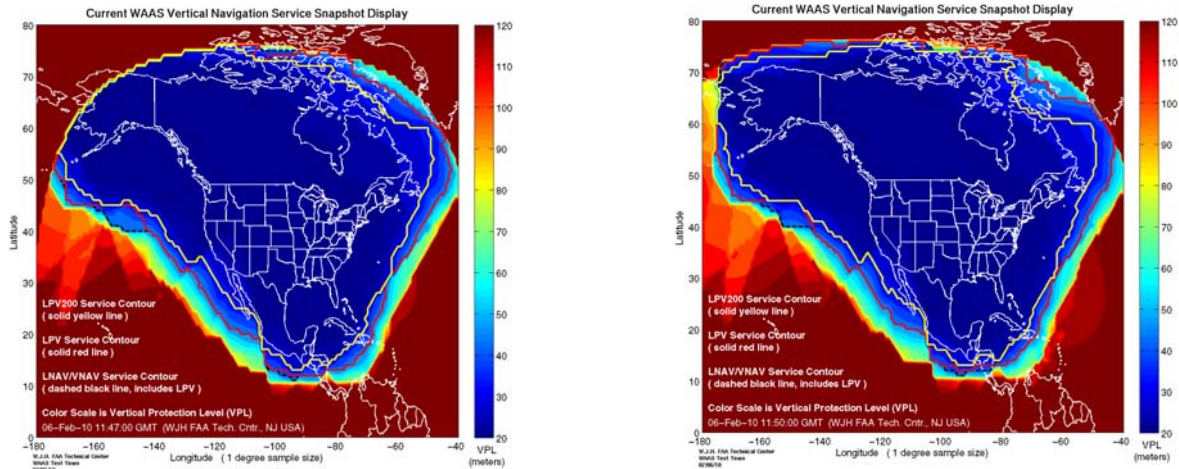
**Figure 4. North America Coverage Plots during Second CRW SIS Loss**

Figure 4 shows the WAAS LPV coverage just before the end of the outage and after the outage was over. Figure 5 shows the entire WAAS service volume just before the end of the outage and after the outage was over.
