**WAAS Technical Report**  
**William J. Hughes Technical Center**  
**Pomona, New Jersey**  
**5/2/07**

**DR#52: Ionospheric Scintillation caused High Position Errors at Fairbanks**  
**GPS Week/Day: Week 1420 Day 5 (March 30, 2007)**

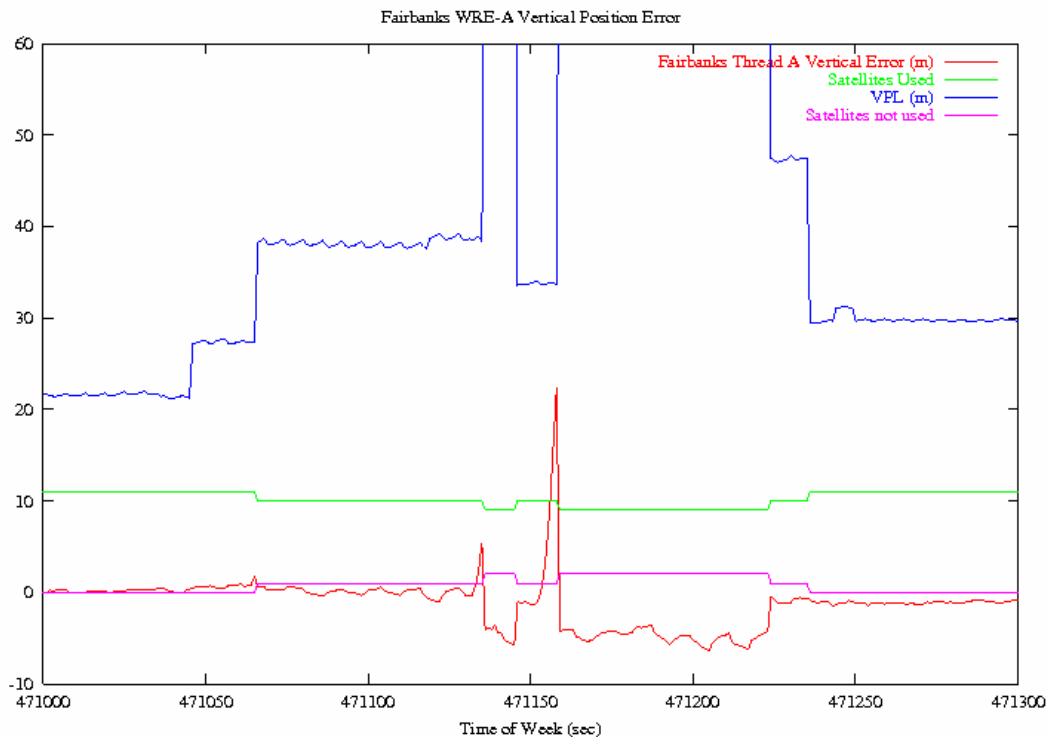
**Figure 1: Fairbanks Thread A Vertical Position Error and Vertical Protection Level**

**Discussion:** On March 30, 2007 (GPS Week 1420 Day 5), large vertical position errors (VPE) were observed at Fairbanks WAAS reference receiver thread A (WRE-A). The vertical errors occurred when WAAS vertical protection levels (VPL) were less than 50 meters, which would allow LPV operations. The maximum vertical error during the event that lasted five seconds was 22.492 meters at 471158 GPS time of week (GMT 10:52:38) and is shown as the red trace on Figure 1. It should be noted that the VPE did not exceed the VPL at any period. The horizontal errors were unaffected during the event reaching a maximum error 1.879 meters. The ratio of the vertical position error (VPE) divided by the VPL was also high (0.669) indicating the VPL (blue trace in figure 1) did not increase at the time of the event. The VPL increased when satellite measurements were rejected from the navigation solution or dropped from receiver tracking.

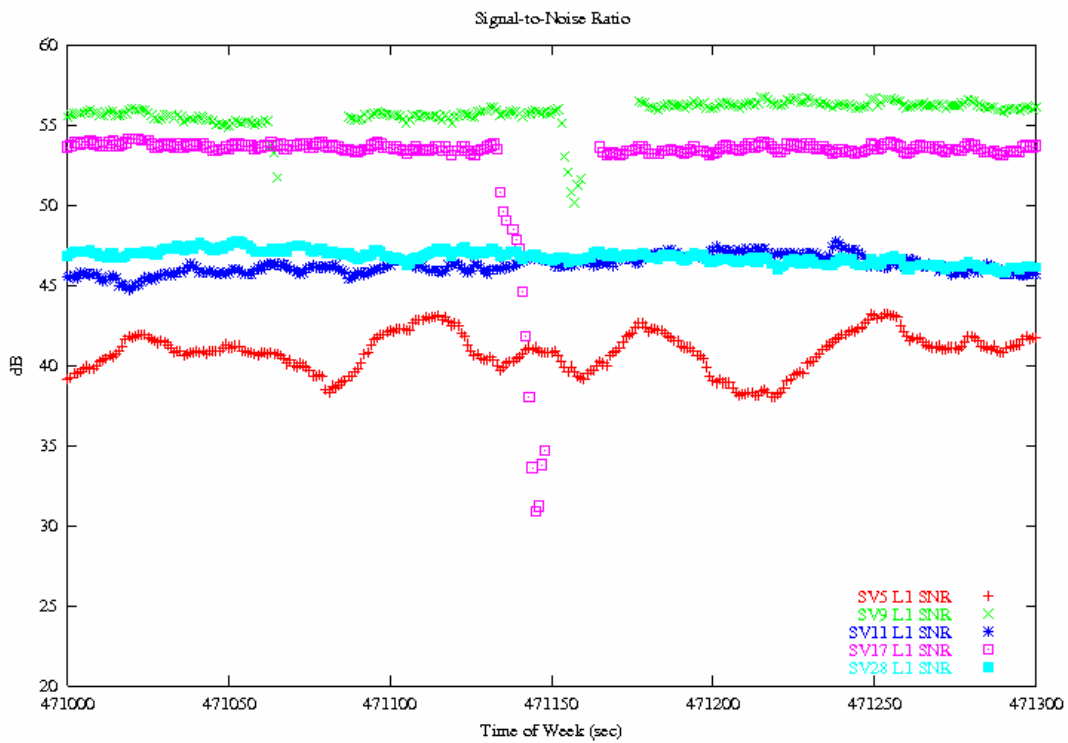
**Figure 2: Signal-to-Noise ratio of several satellites**

The sharp increase in VPE was incidental to satellite tracking interruptions of PRN 9 and PRN 17, which were at relatively high elevations of 64 degrees and 55 degrees respectively. The L1 signal strength of carrier to noise (C/No) for the satellites are shown on Figure 2 and sharply decrease for PRN 9 & 17 before and during the time of the anomalous VPE. The signal strength of other satellites tracked remained unaffected with a subset of receiver satellite C/No shown on figure 2 for reference.

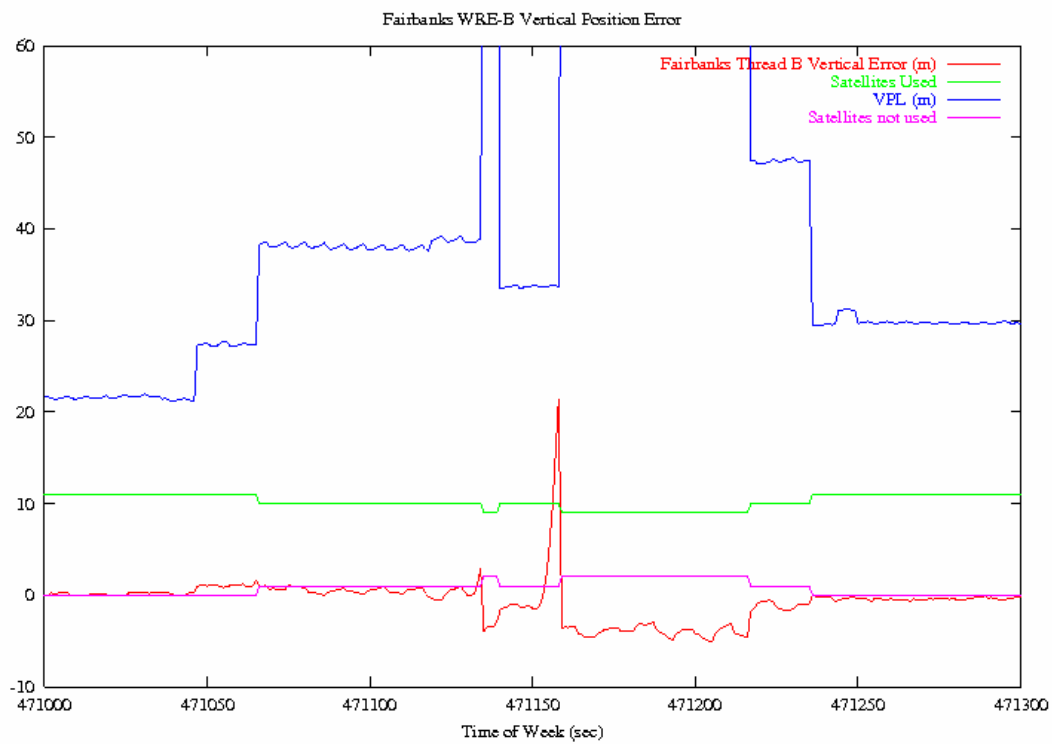
**Figure 3: Fairbanks Thread B Vertical Position Error and Vertical Protection Level**

Fairbanks threads B and C reference receivers also experienced high vertical errors and maximum VPL/VPE ratios. Thread B had a maximum vertical error of 21.456 and a maximum ratio of 0.638 shown in Figure 3. Thread C had a maximum vertical error of 15.665 and a maximum ratio of 0.461 shown in figure 4.

The satellite tracking problems were consistent at all three receivers at Fairbanks at the time of the maximum VPE. Figures 3 and 4 show the Vertical Position Errors and VPL for threads B and C respectively. The plots also indicate the number of satellites in use (green trace) during this time period. As can be seen from the plots, the vertical errors and VPL's on all three threads did not vary significantly during this time period. Thread C had a lower maximum vertical error than threads A and B because satellite 9 was dropped one second earlier on thread C than on the other threads.

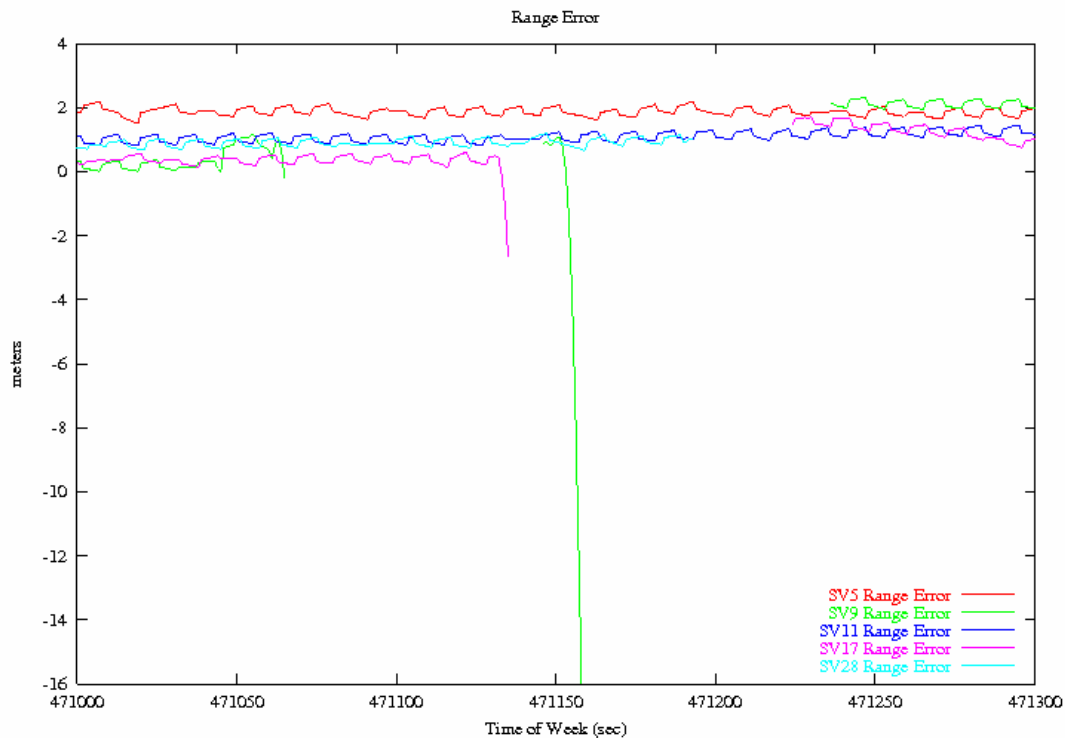
**Figure 5 Satellite Range Error at Fairbanks WRE-A**

Figure 5 shows the range errors of several satellites tracked and used in the navigation solution during the VPE anomaly. The figure shows PRN 9 range error (shown as the green trace) magnitude increasing to  $-16$  meters at the same time of the maximum vertical errors were observed. PRN 9 was subsequently dropped from the receiver track list and removed from the navigation solution, at which time the magnitude of the vertical error dropped to less than 5 meters and the VPL jumped from 33 meters to 110 meters (Figure 1). Independent data analysis at other Alaska reference receivers showed that WAAS satellite and ionospheric corrections did not contribute to the satellite PRN 9 range error.

Satellite PRN 17 (magenta trace) also experienced increasing range errors and was dropped from the navigation solution due to L1 carrier cycle slip detection at 471135 GPS time of week and did not significantly affect navigation performance. The range errors for the other satellites used in the navigation solution were unchanged during this time period and a subset are shown in Figure 5 for reference.

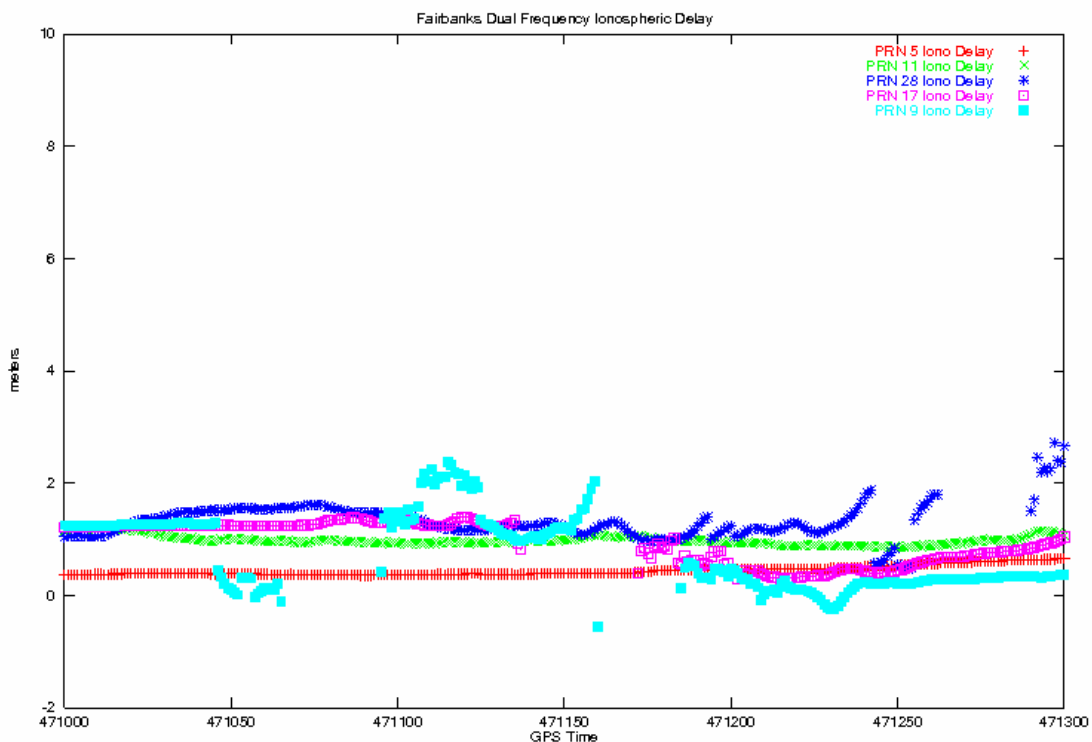
**Figure 6: Dual Frequency Ionospheric Delay**

Figure 6 shows the dual frequency ionospheric slant delay observed by several satellites tracked during the same time period. The total electron content (TEC) was relatively small producing 1 – 2 meters of delay at the L1 frequency for the satellites shown in Figure 6. The ionospheric delay of satellites PRN9, PRN 17 and PRN 28 experienced moderate sinusoidal fluctuations before L1 and L2 loss of code and carrier lock by the receiver indicating ionospheric scintillation may have contributed to the poor receiver tracking of these high elevation satellites. After satellite reacquisition there is typically more noise on L1 and L2 receiver measurements as seen on satellite PRN 9 (aqua trace), which was most affected by scintillation and dropped from receiver tracking twice during the period.

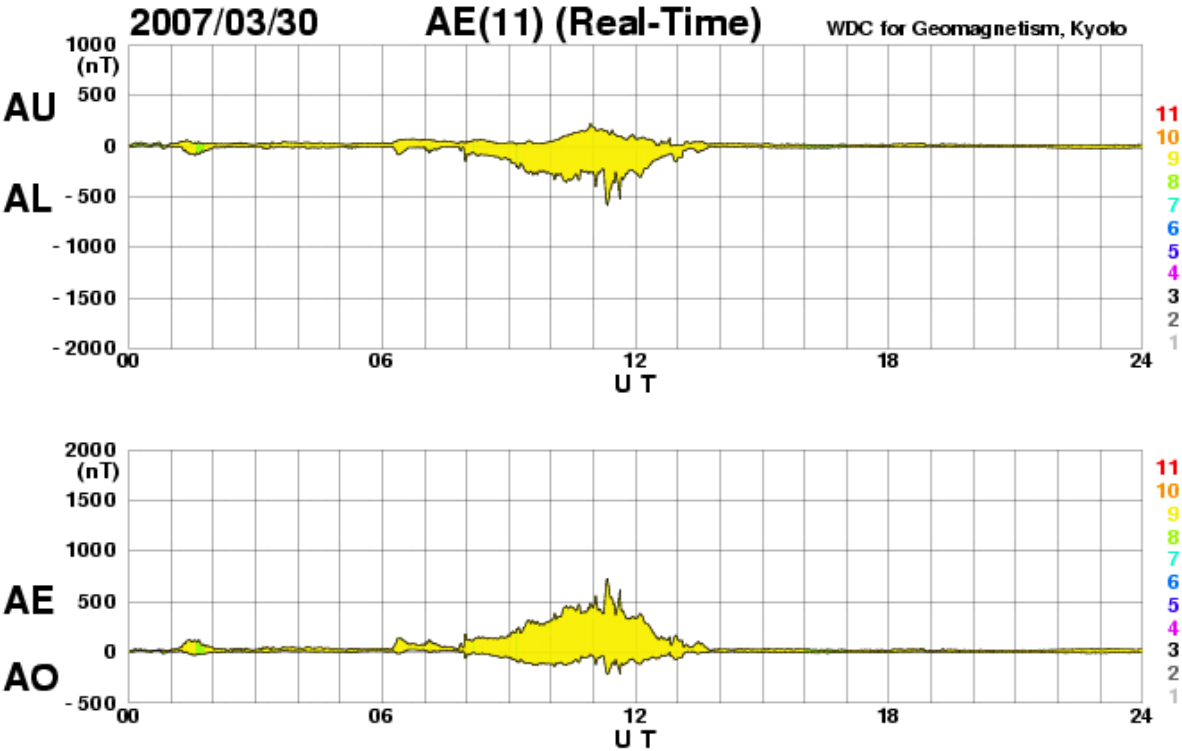
Figure 7: Auroral Electrojet Index

Figure 7 is a plot of the Auroral Electrojet Index, which shows the aurora's effects on Earth's magnetic field. The times of increased activity correspond to the times when high errors were reported at Fairbanks.

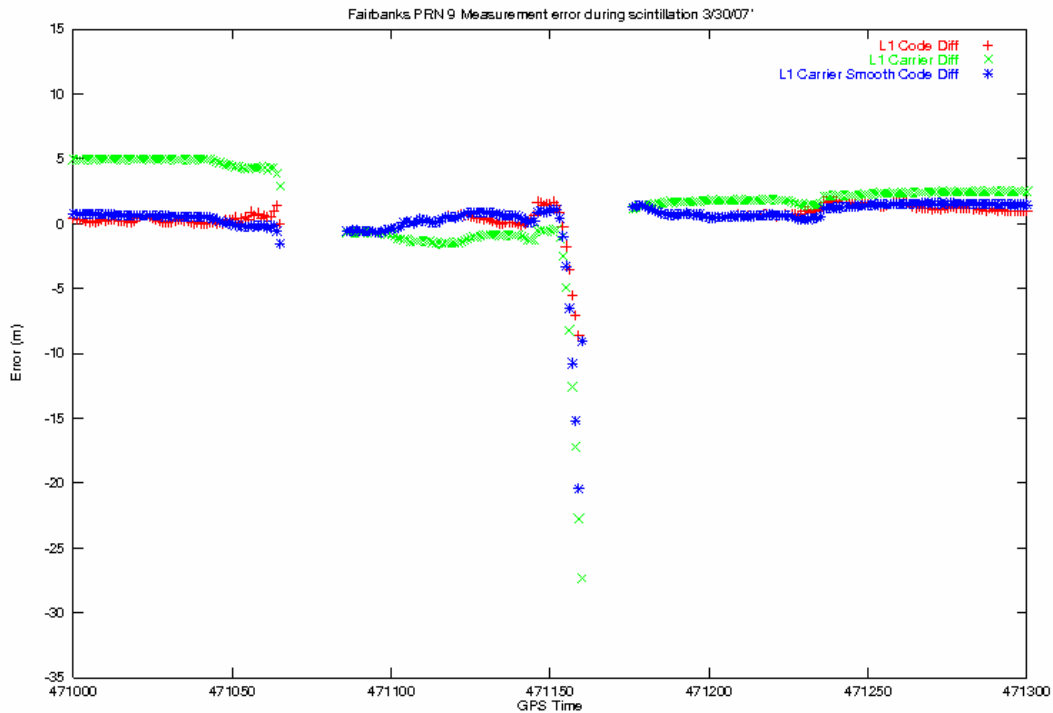
**Figure 8: Satellite PRN 9 L1 Code and Carrier Measurement Errors**

Figures 8 and 9 show the code (red trace) and carrier (green trace) measurement errors for satellites 9 and 17 respectively. The measurement error of the 100 seconds carrier smooth code is shown as the blue trace and is the measurement used in the least square navigation function, which determines the user position. As Figure 8 shows, after satellite PRN 9 is reacquired at 471085 GPS time of week it was tracked for only 68 seconds before large carrier measurement errors grew to 30 meters within 7 seconds before the receiver lost track of the satellite signal. The receiver measurements for PRN 9 and PRN 17 (Figure 9) both had common error signatures before the loss of tracking occurred, however the validity of PRN 17 receiver measurements was flagged as invalid due to carrier cycle slip, which minimized the vertical position error to 4.9 meters at 471135 GPS time of week. PRN 9 measurement errors were not detected by the receiver or signal processing functions and were introduced into the navigation solution causing the vertical error to grow to 22 meters before the satellite measurements were eventually flagged invalid.
